## The World Trade Center Bombing: Report and Analysis

Provided by *Fire Engineering*

# **The World Trade Center Bombing: Report and Analysis**

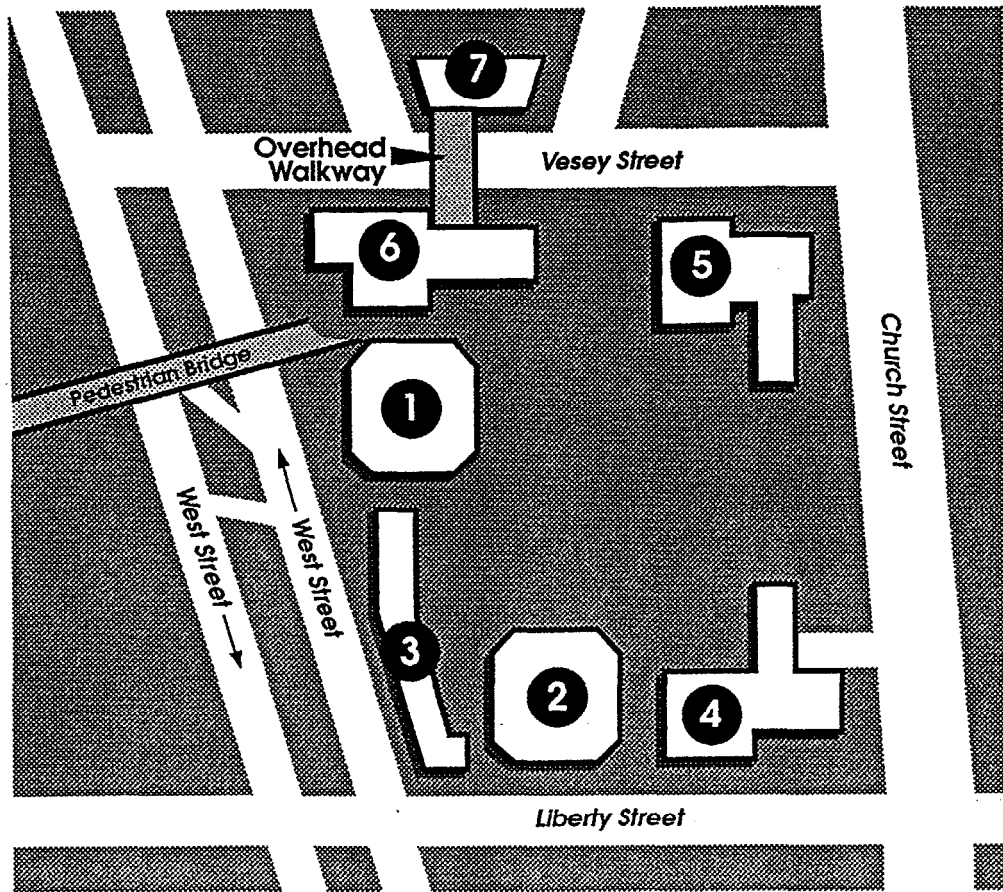
## World Trade Center Complex

- 1 World Trade Center - 110- story office tower
- 2 World Trade Center - 110- story office tower
- 3 World Trade Center - 22- story Vista Hotel
- 4 World Trade Center - 9- story office building
- 5 World Trade Center - 9- story office building
- 6 World Trade Center - 8- story Customs House
- 7 World Trade Center - 47- story office building

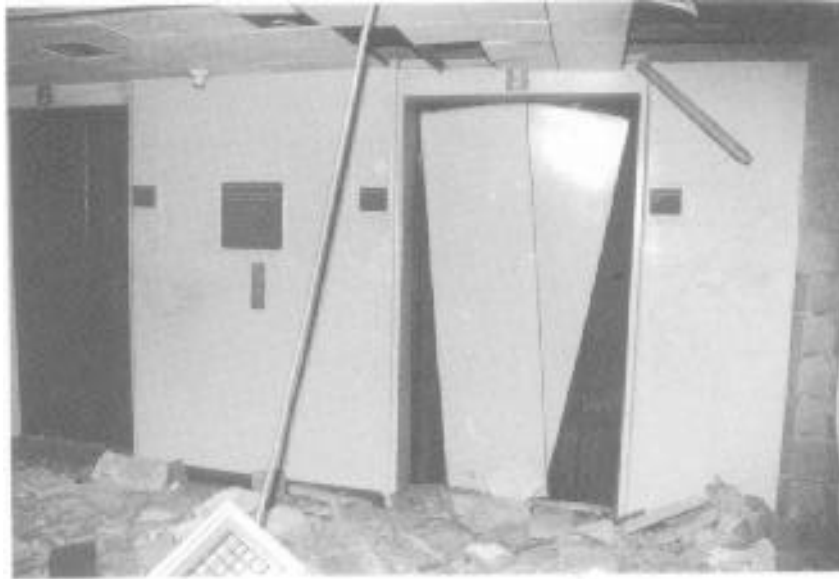
Damaged elevator doors and enclosures on the B-2 level presented a vertical channel for smoke spread into Tower 1. (Photo courtesy of Port Authority Risk Management.)

Above grade. The large quantities of smoke that had been generated prior to the fire's knockdown became a major operational factor. Due to the destroyed elevator shaft doors at the B-2 level, the hole in the Vista Hotel meeting room with the blown-out glass partition wall between the Vista Hotel and Tower 1, and doors being opened on all floors by people evacuating - and with the stack effect working - most floors and all stairways of Tower 1 and the Vista Hotel became charged with smoke. Tower 2 had a smoke condition but to a lesser degree. The smoke condition in Tower 1 was the worst of the three buildings above grade.

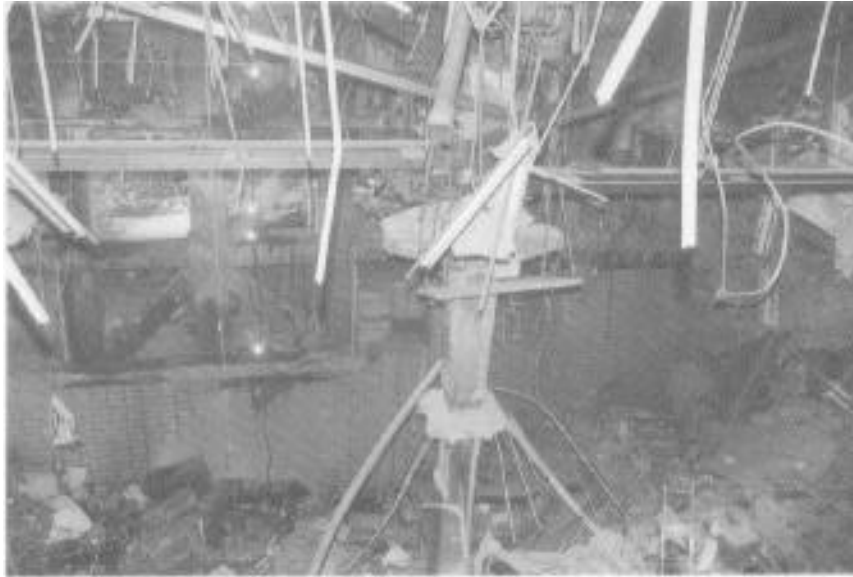
A view of the crater from the B-1 to B-5 levels. Note the steel column. Horizontal supports were destroyed in some cases, but the columns did not give. (Photo courtesy of Port Authority Risk Management.)

- An L-shaped crater, approximately 130 by 150 feet at its maximum points, was opened, collapsing reinforced concrete and debris onto levels below.
- At least nine steel columns were heavily damaged and left without lateral support.
- Many walls collapsed, including a concrete block wall adjacent to the blast area that collapsed onto and killed five WTC personnel.
- Doors/enclosure walls of Tower 1 elevator shafts were heavily damaged.
- Some 200 vehicles were fully or partially destroyed, and many were on fire.
- Primary electrical power feeder lines were damaged.
- Stairway doors and shaft walls were heavily damaged.
- Some standpipes were damaged.
- The sprinkler system in the immediate blast area was destroyed.

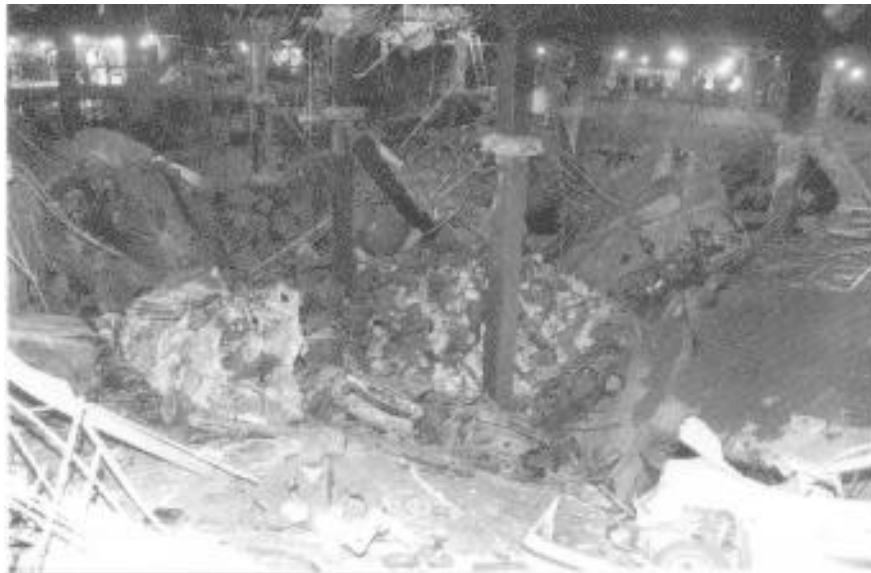
The crater, looking from the B-2 level down to B-5, taken during the investigation/restoration phase. (Photo courtesy of Port Authority Risk Management.)

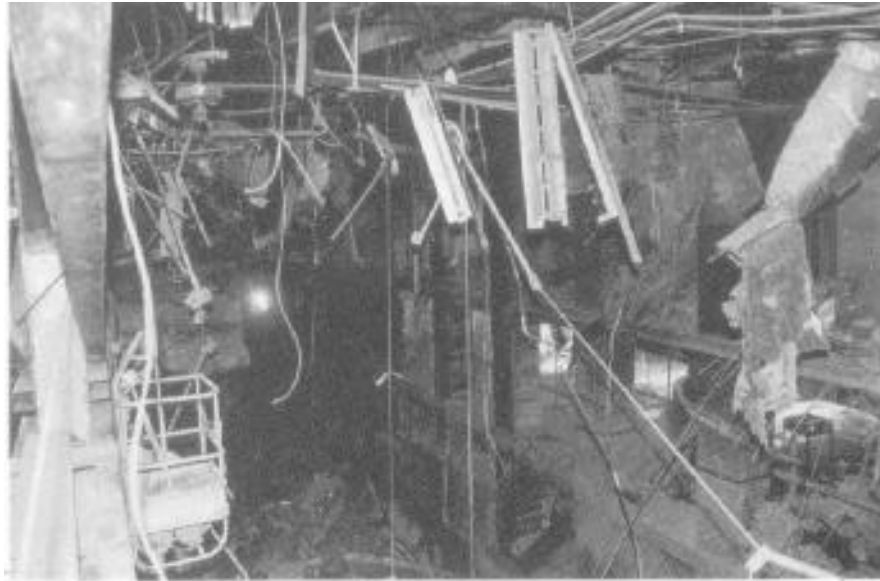
Firefighter Shea's fall was a long one—some 40 feet. The smoke condition in the crater was such that visible contact with Shea was impossible. (Photo by FDNY Photo Unit.)

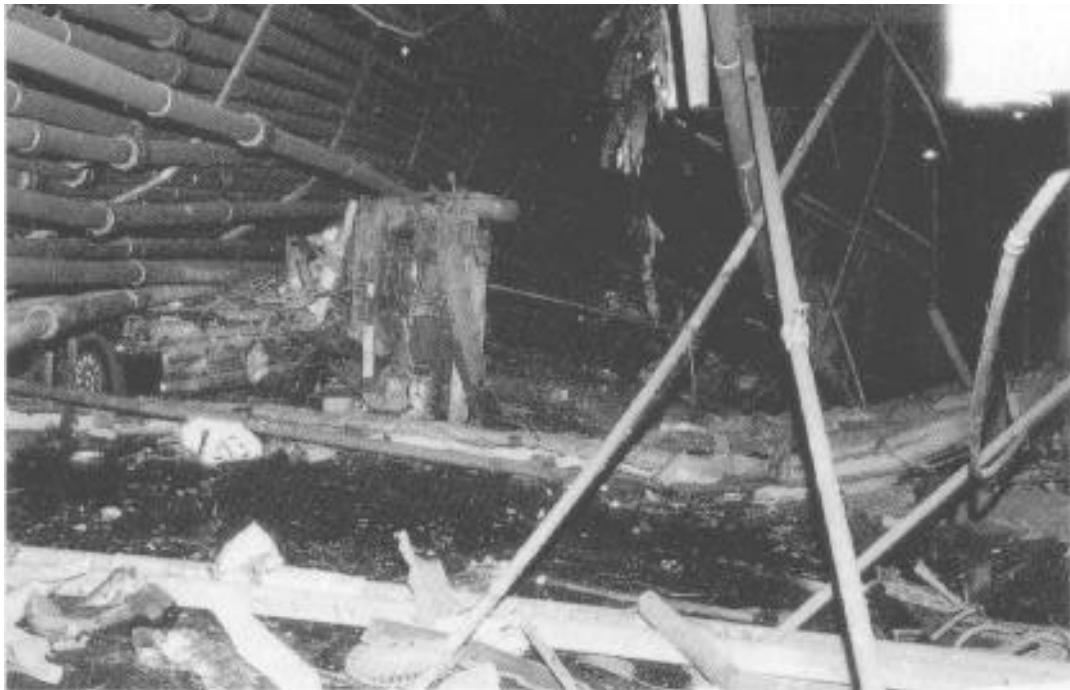
Building systems in the vicinity of the blast were destroyed. Here, twisted electrical conduit has landed on top of what was once a car. (Photo by FDNY Photo Unit.)

***Damage/hazard assessment.*** Lights were brought into the below-grade areas. Damage from the blast was extensive. The B-2 level surrounding ground zero was completely destroyed. Piping and conduit were snapped like twigs. Masonry walls and steel-reinforced concrete flooring were blown apart. Cars were strewn about like toys. Steel columns were shocked but held.

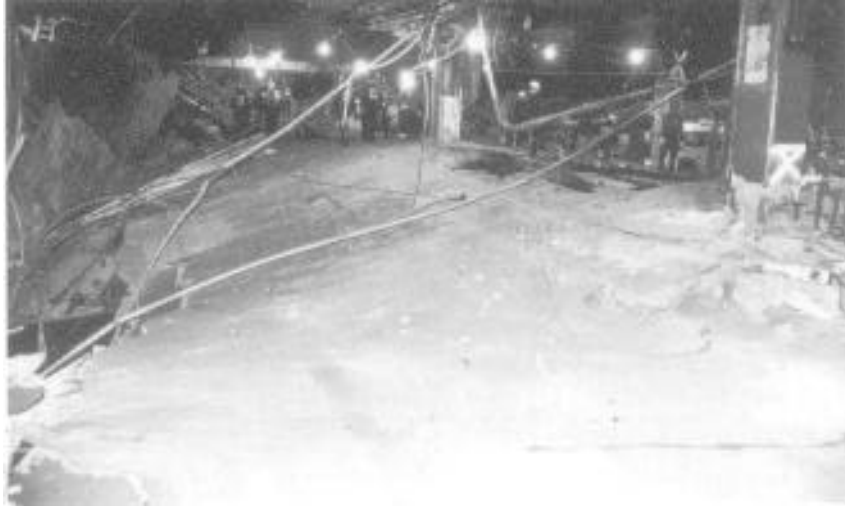
The sloping, hanging steel-reinforced concrete floor at the perimeter of the crater was a major hazard for units operating on the crater fire, particularly in the heavy smoke condition. (Photo by FDNY Photo Unit.)

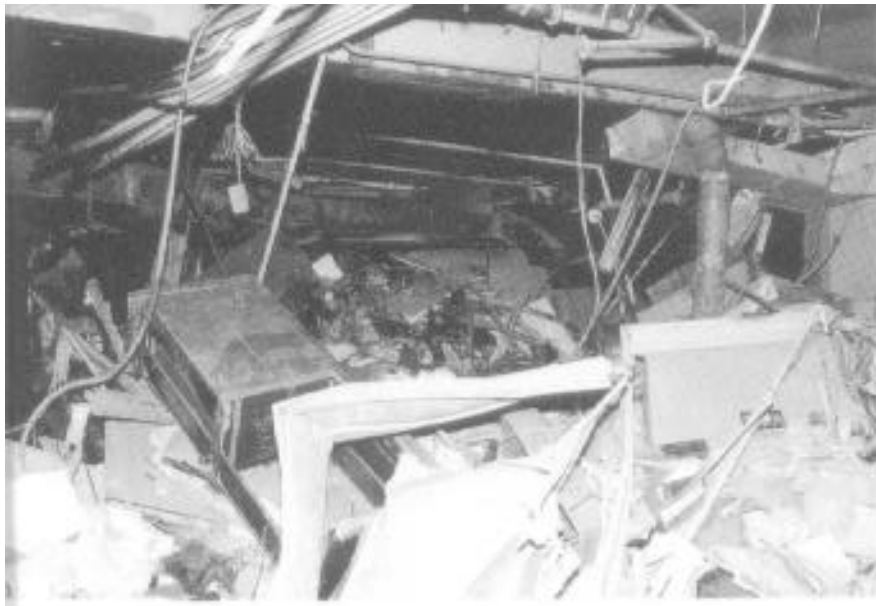
This destroyed office area on the B-2 level is typical of the debris piles faced by searching firefighters. (Photo courtesy of Port Authority Risk Management.)

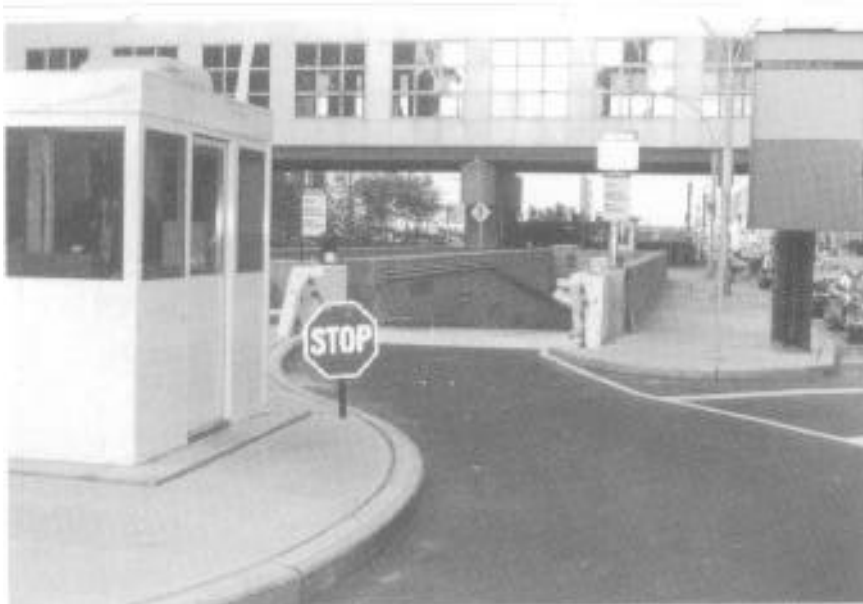
Controlling access to public buildings is a major concern for building management. After the incident, Port Authority, in addition to many security changes, installed substantial barriers to unauthorized vehicle access. The barrier, controlled by security personnel in the booth, folds down when the driver has been cleared to enter. (Photos courtesy of Port Authority Risk Management.)
